Workplace Health and Safety Queensland Elevating Work Platform Tyres 12/3/2014

Issue

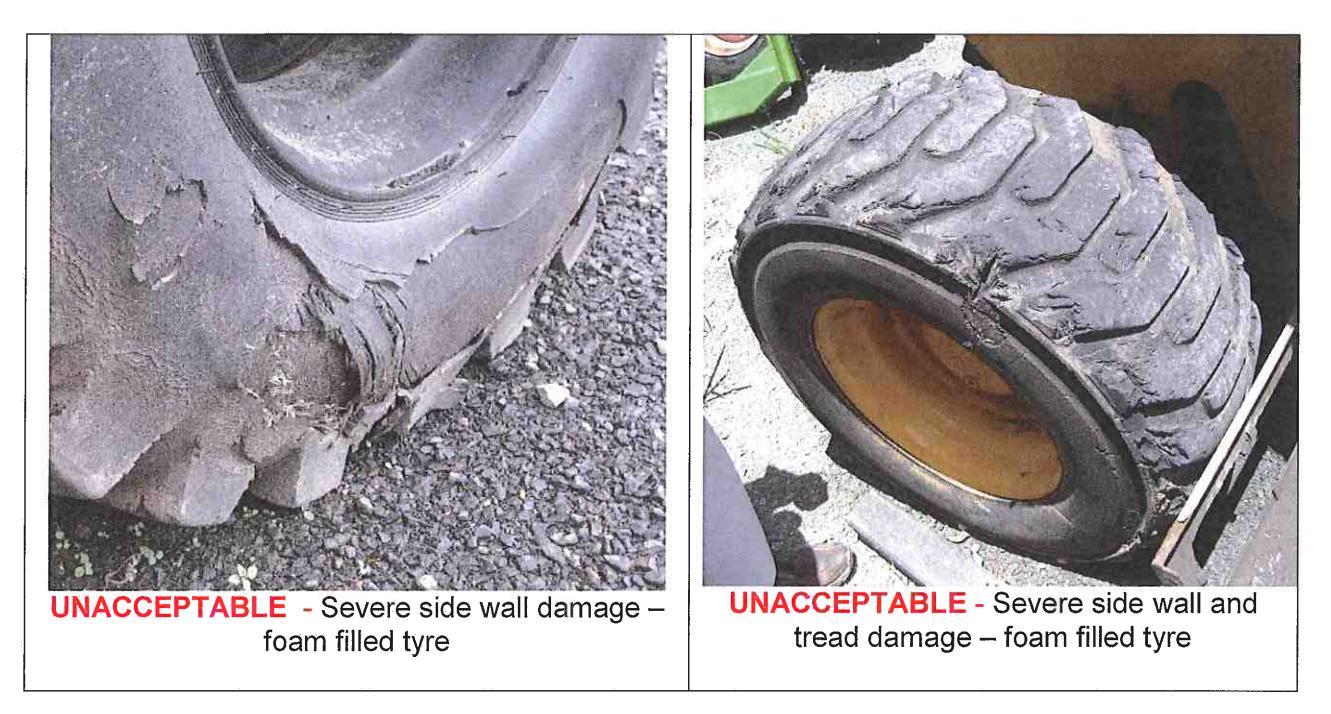
UNACCEPTABLE TYRE CONDITION - EWP SHOULD NOT BE USED

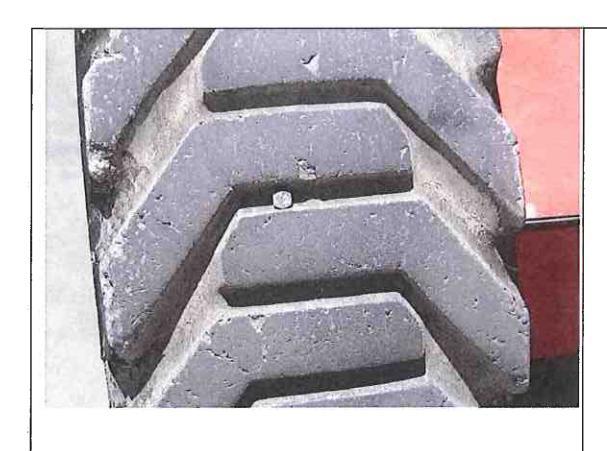
Bolt in tyre –this is not a fault - bolt is used to plug the air hole after filling.

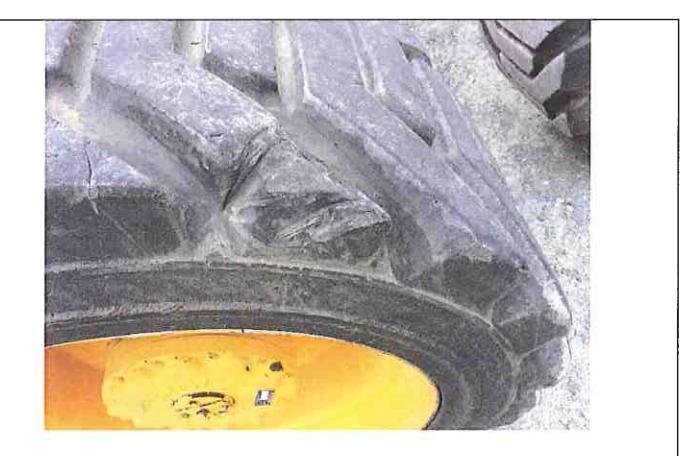
Non-critical - Small amount of tread missing but outer case is not damaged.

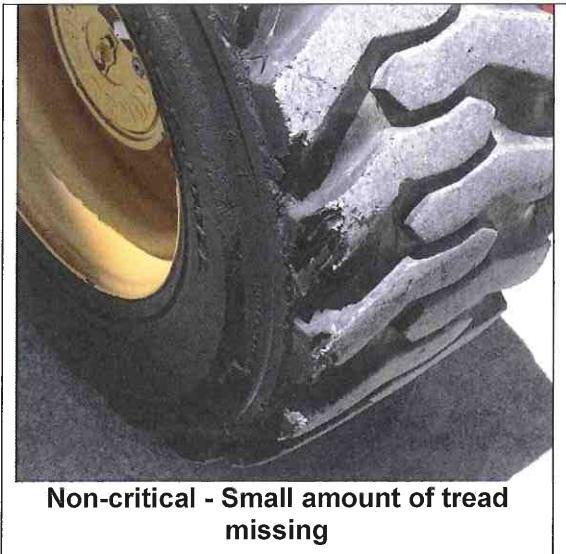
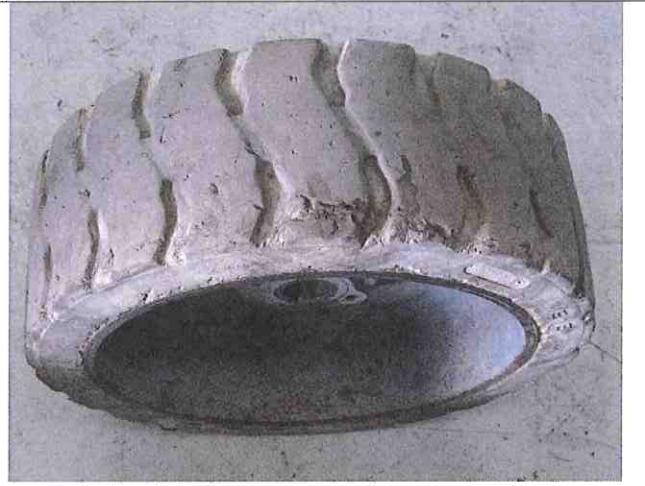
Non-critical - Small amount of tread damage and minor wear
